REPORT ON THE LARGE SCALE FIRE PROPERTIES OF MICON “THATCHBOR FR” FIRE RETARDANT THATCH TREATMENT

Sep 1998

Division of Building Technology, CSIR
PO Box 395 Pretoria 0001
Republic of South Africa

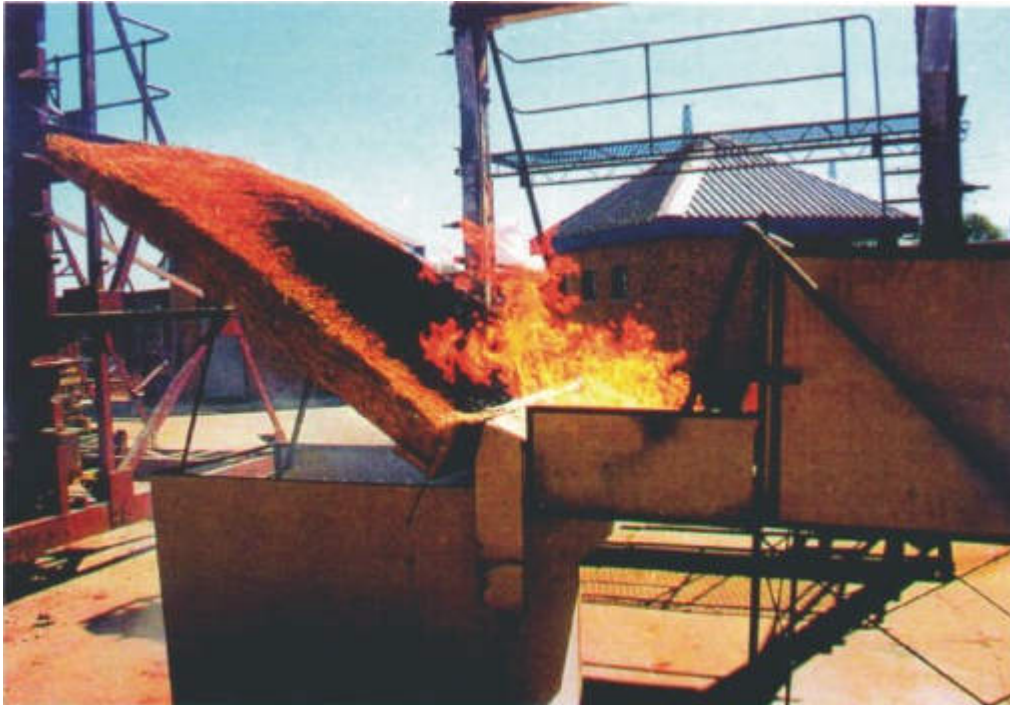
Figure 3: Intermittent flame test
Test set up during a flaming cycle

Figure 3 shows the test installation during one of the 2 minute flaming cycles. During the early cycles the material on the exposed surface was charred during the flaming cycles while no flaming was observed on the test panel during the no-flaming cycles (figure 4). During the eighth cycle (when the burner was off) some flaming was observed on the underside of the test panel (figure 5). Some fine ash fell to the ground during the test period but at no stage did any burning or glowing brands fall apart from the test roof.

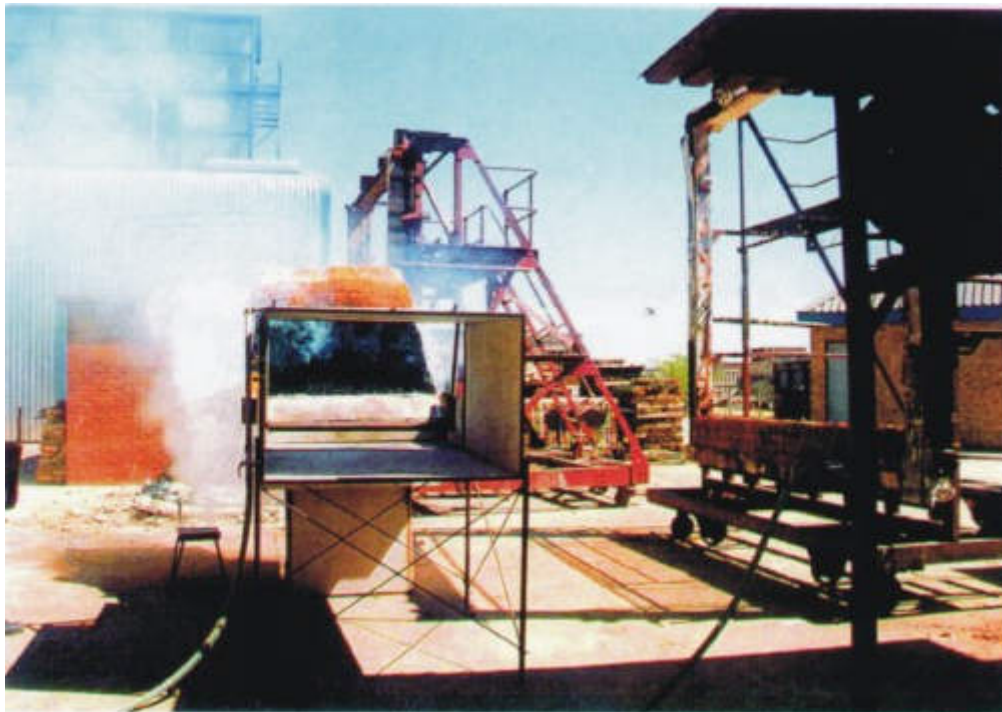
Figure 4: Intermittent flame test
Thatch roof panel during a non flaming cycle

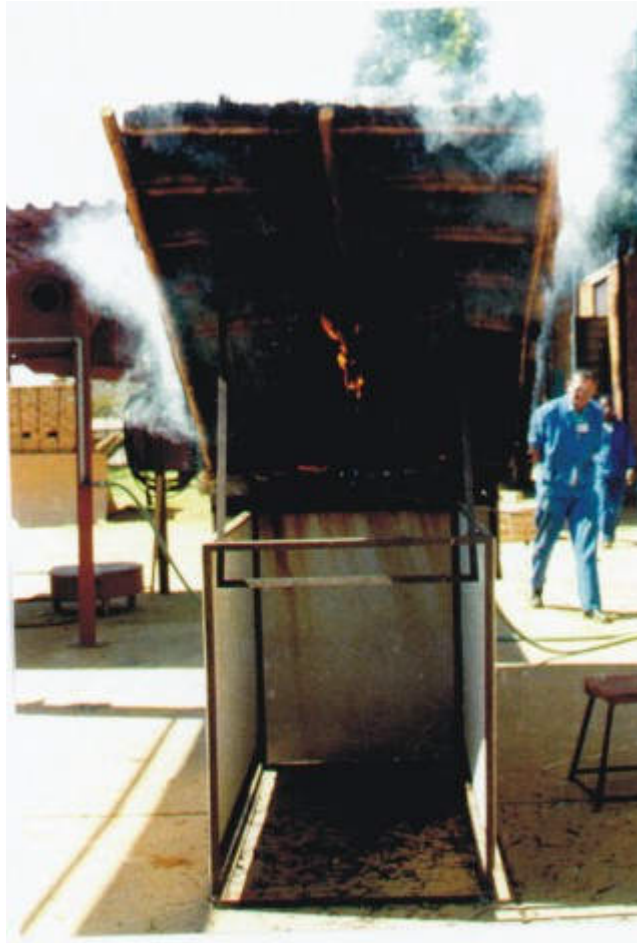
**Figure 5: Intermittent flame test:
Flaming on the underside of test roof during 8th cycle**

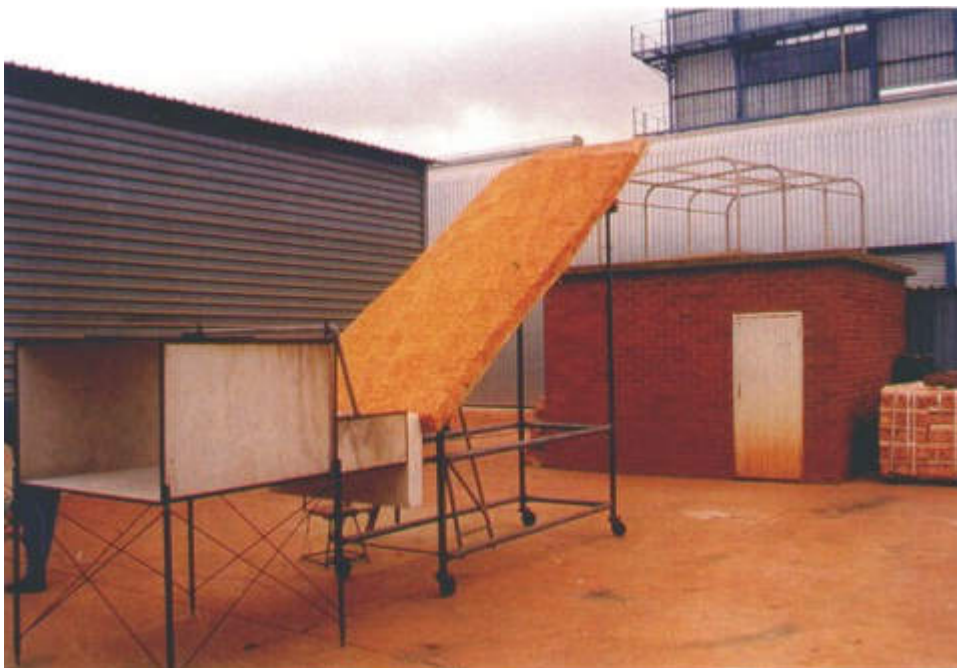
**Figure 6: Spread of flame test:
Test set up prior to ignition**

Figure 6 shows the test panel prior to ignition of the burner while Figure 7 was taken immediately after ignition of the burner. Some charring occurred over the bottom half of the panel with small surface flames observed during the initial stages of the test (figure 8). This flaming subsided after a while although some glowing of the thatch along the bottom edge was noticed (figure 9). Small flames appeared on the underside after approximately 8 minutes (figure 10). No flaming was observed on the panel after the burner had been extinguished although the glowing on the bottom edge persisted (figure 11). The underside of the panel was slightly charred but the small flames had disappeared (figure 12). Although some smoke was still being evolved by the roof, the visible flaming along the bottom edge subsided within 10 minutes of the burner being extinguished (figure 13). At no stage during the test did any burning or glowing brand fall to the floor and the distance of flame spread along the length of the sample (disregarding the length of the burner flame) was taken to be approximately 1.5m.

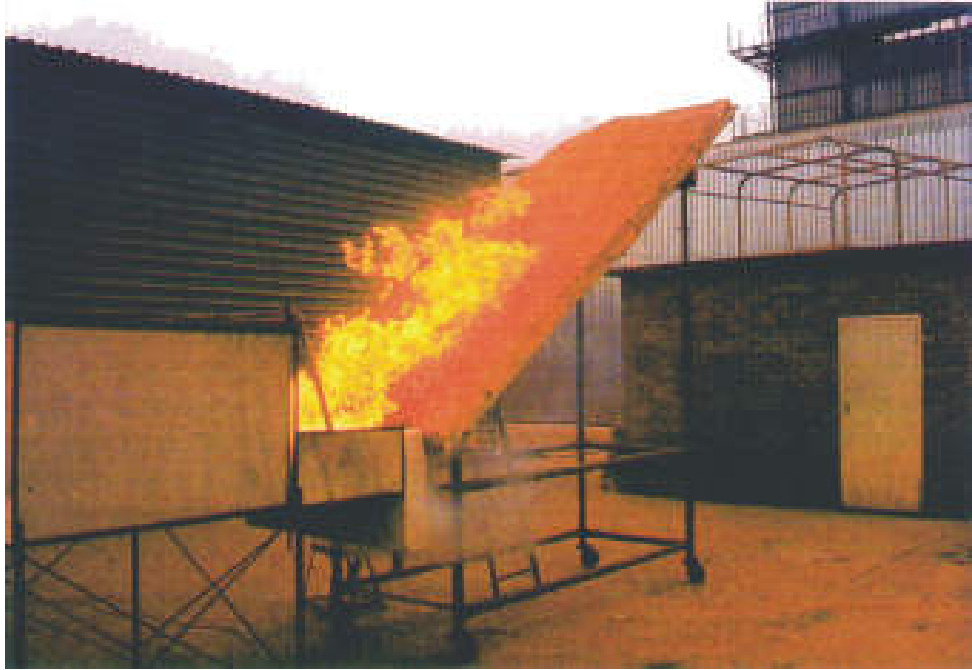
**Figure 7: Spread of flame test
Ignition of burner**

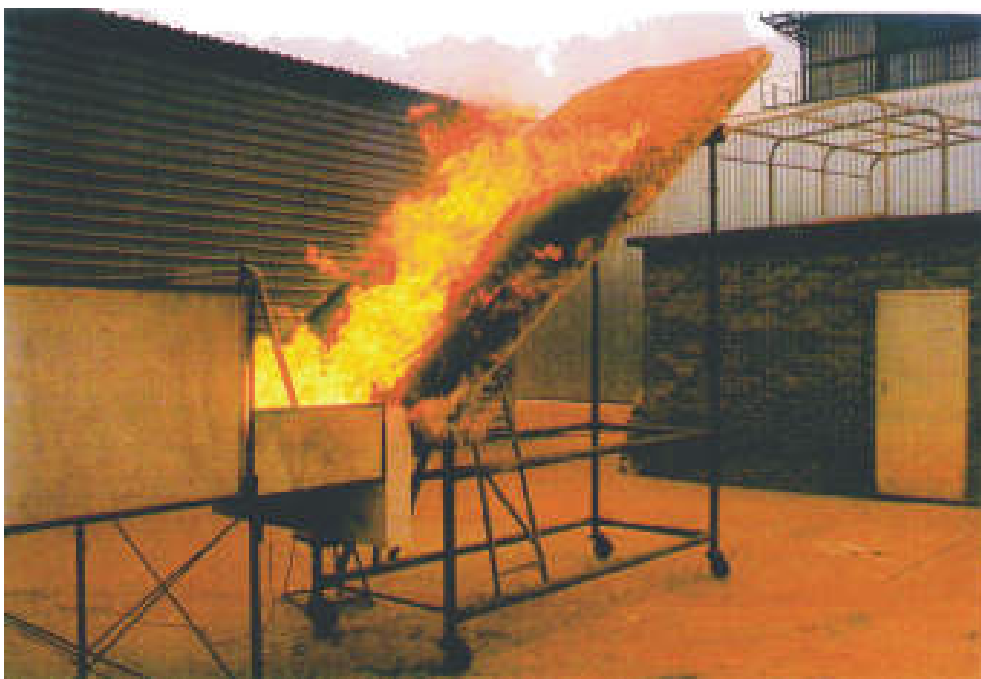
**Figure 8: Spread of flame test
Charring and small flames on surface**

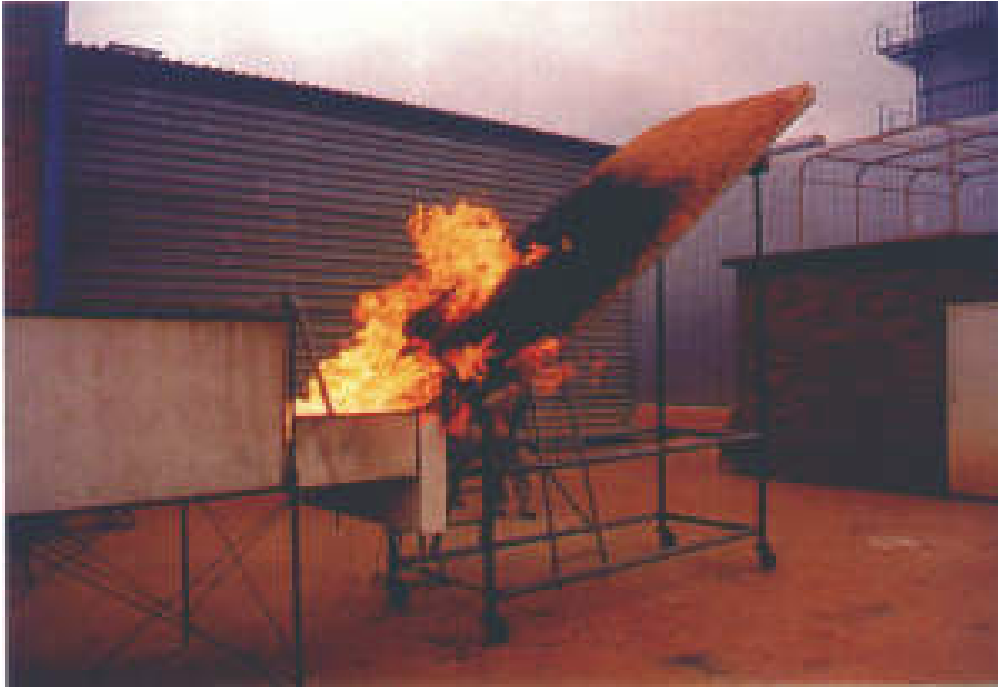
Figure 9: Spread of flame test
Flames on thatch panel surface subsided

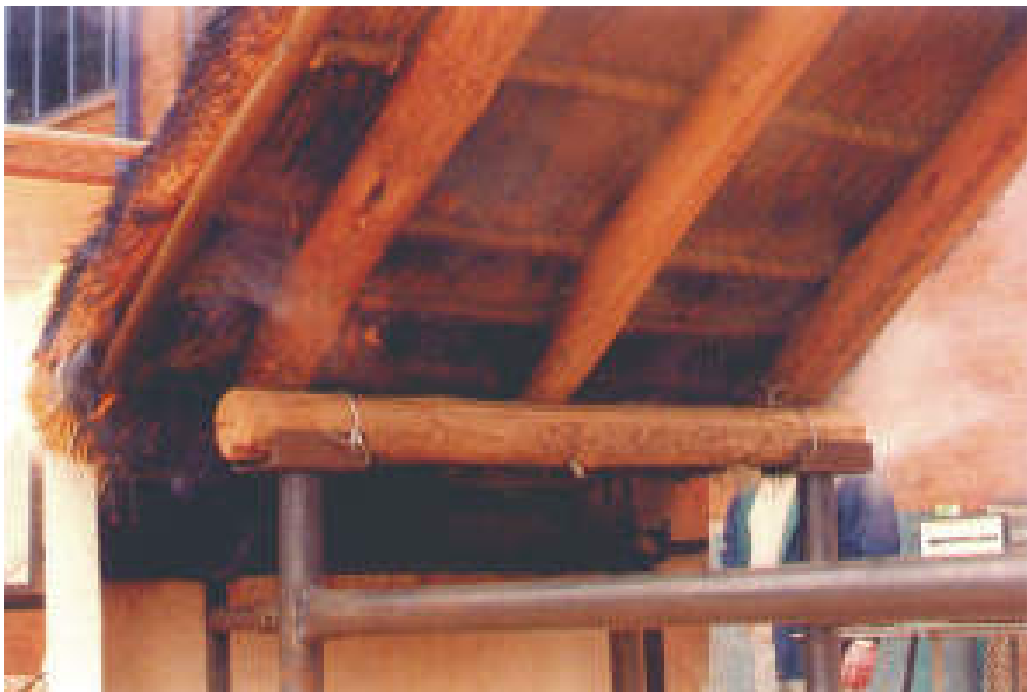
Figure 10: Spread of flame test
Small flames on underside of panel

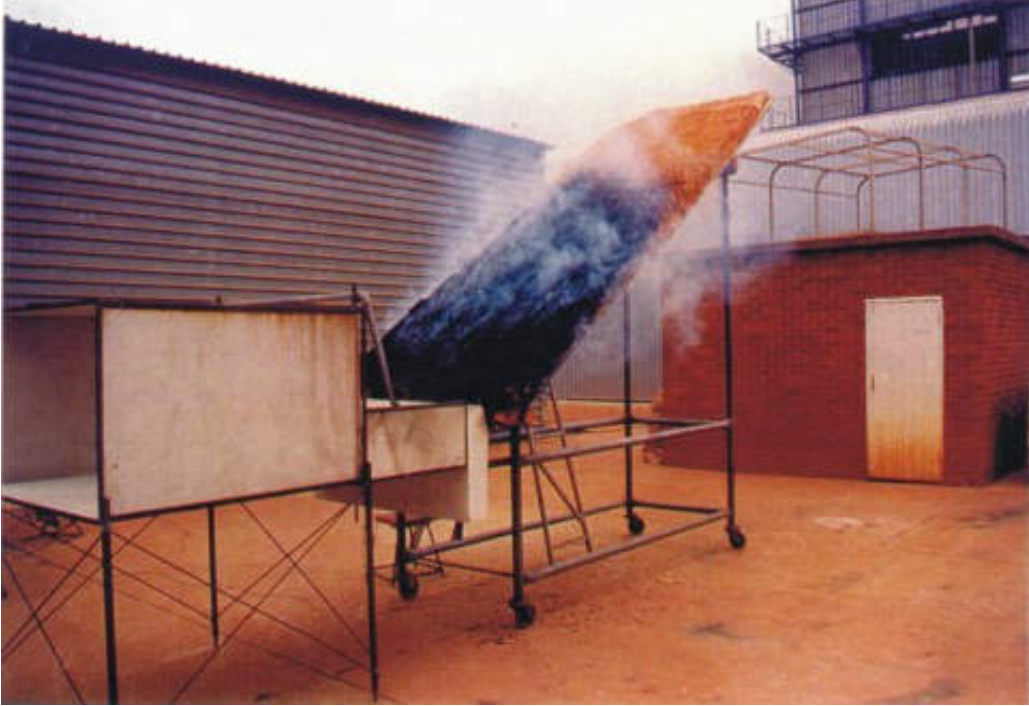
**Figure 11: Spread of flame test
Burner extinguished**

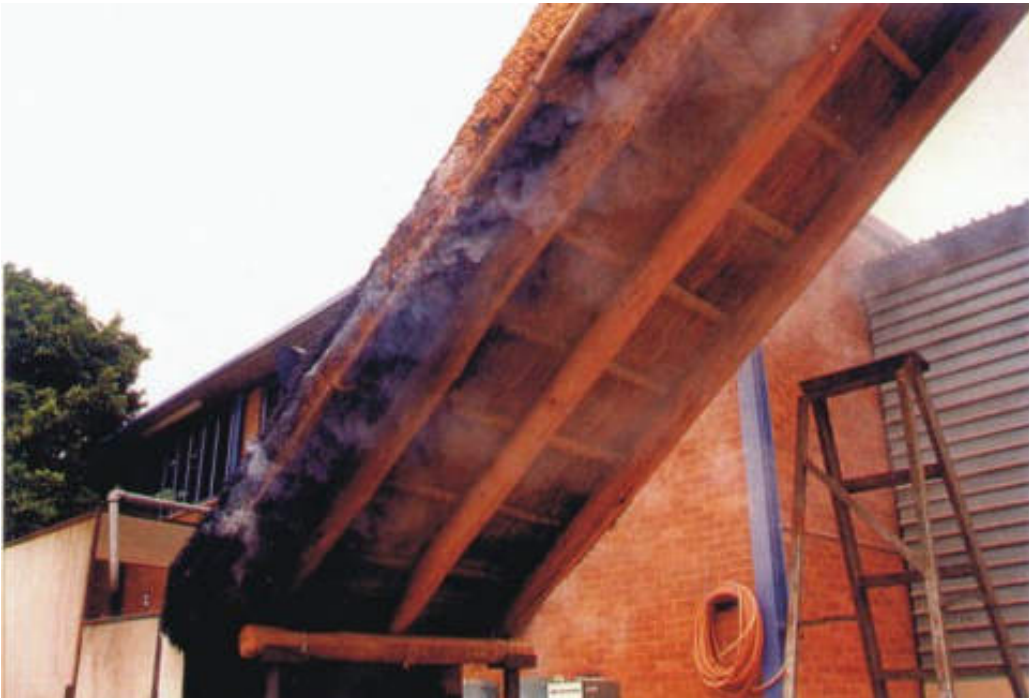
**Figure 12: Spread of flame test
Underside of roof immediately after burner extinguishment**

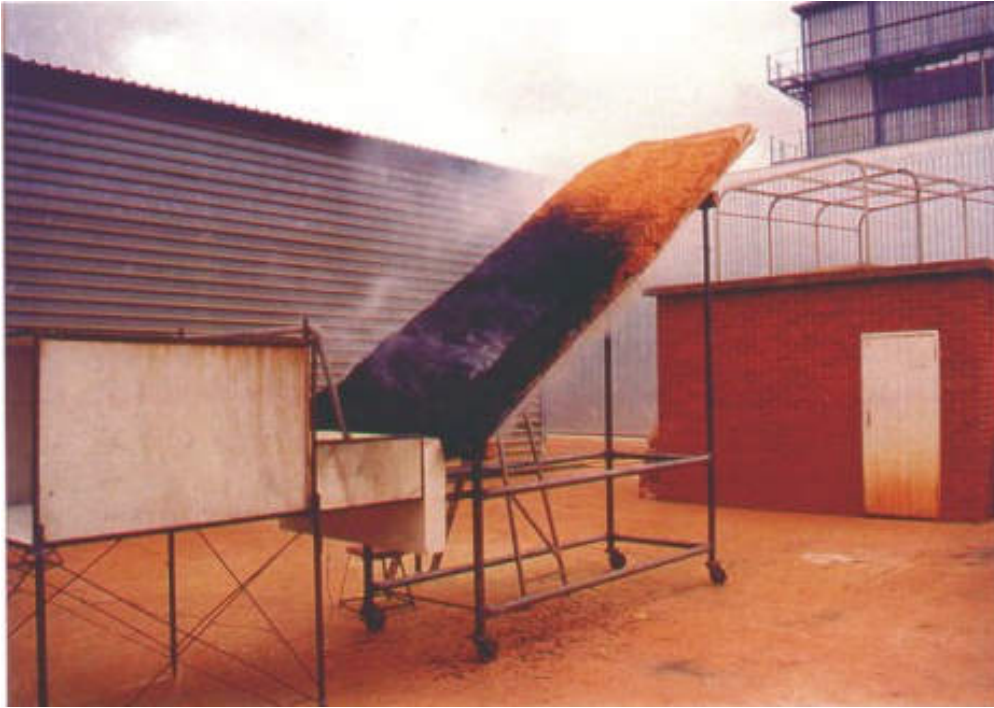
**Figure 13: Spread of flame test
Glowing on bottom edge disappeared**

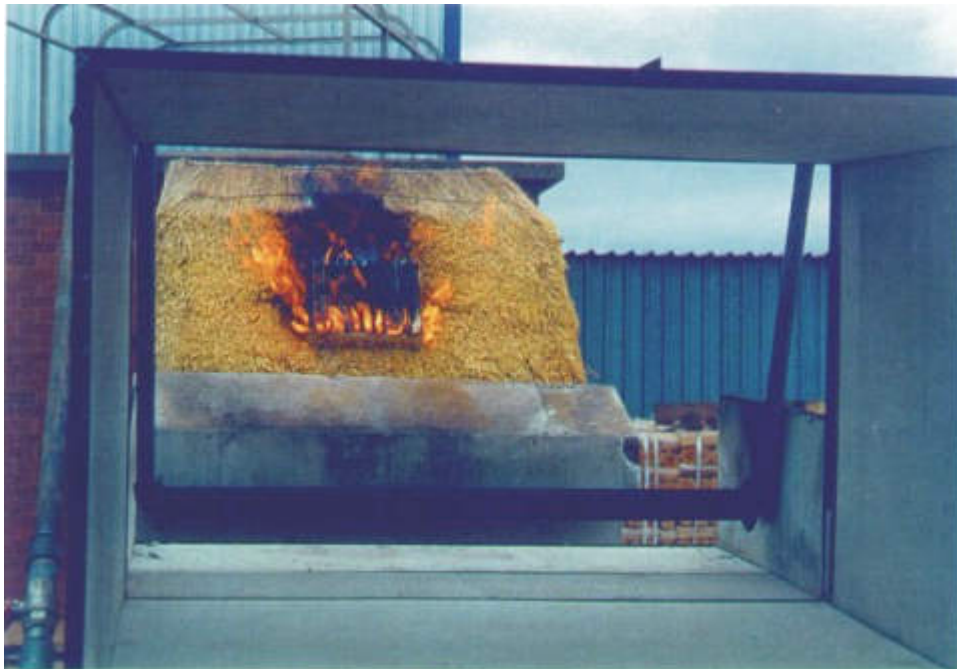
**Figure 14: Burning brand test
Placement of burning brand on thatch panel**

Figure 14 shows the burning brand shortly after being placed in position on the roof. Some charring occurred on the surface but some small flames and glowing was observed in the lower region of the panel as the brand decomposed under the strong air current (figure 15). The flames and glowing disappeared steadily as the brand decreased (figure 16). The underside of the roof was charred in the lower regions with some grass being dislodged in the area directly underneath the brand. No burning or glowing material fell to the ground at any stage during the evaluation.

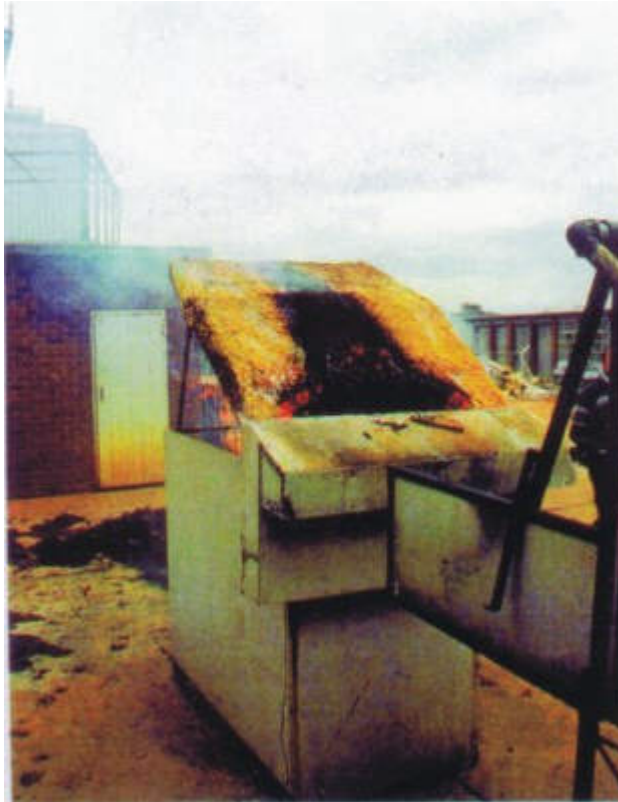
Figure 15: Burning brand test
Glowing and small flames in lower region of panel

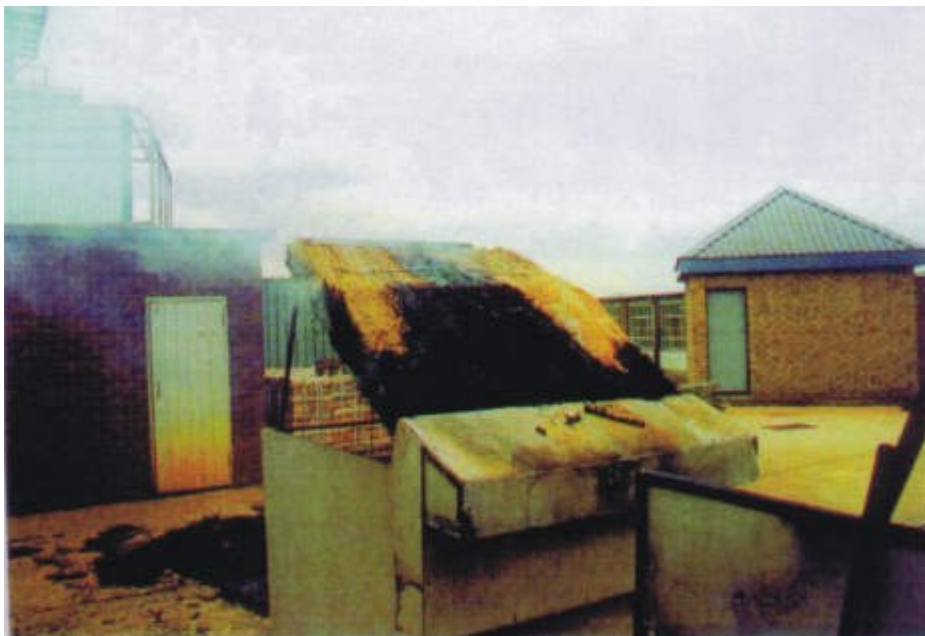
Figure 16: Burning brand test
Effect on brand deceased, visible glowing disappeared

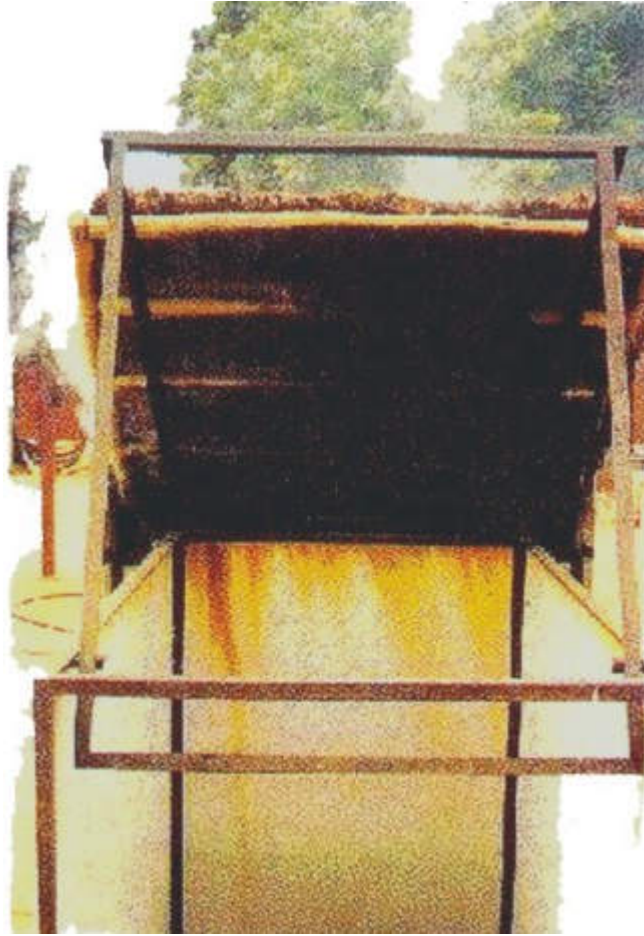
**Figure 17: Burning brand test
Underside of panel after brand was fully decomposed**
